NPDES Inspection Report

Permit # WAR001234

Emerald Services

September 29, 2016

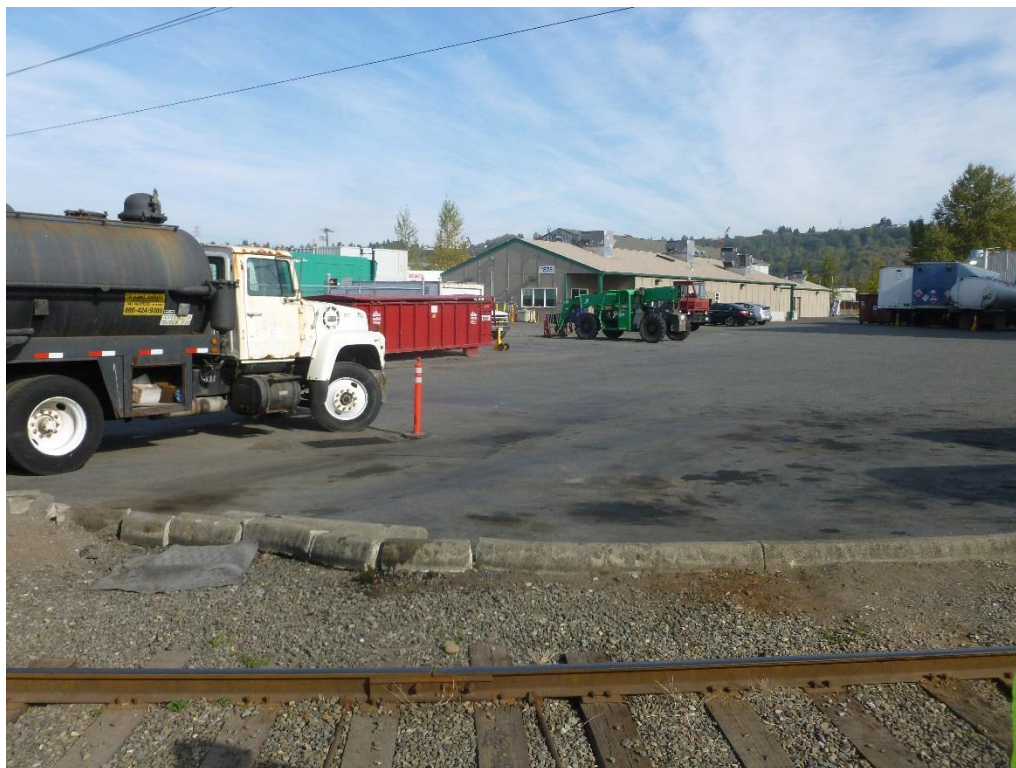
Near the entrance to the facility, I observed stains on the pavement (**Photo 1**). Mr. Garman attributed these stains to leaks from a truck that had been scheduled for maintenance. He said that the industrial vehicle traffic at the facility consists of approximately 12 trucks per day. Mr. Garman said that the paved areas are swept with a street sweeper on a monthly basis.

Photo 1 / P1020788 – Northernly view of stains on the pavement near entrance Gate 3

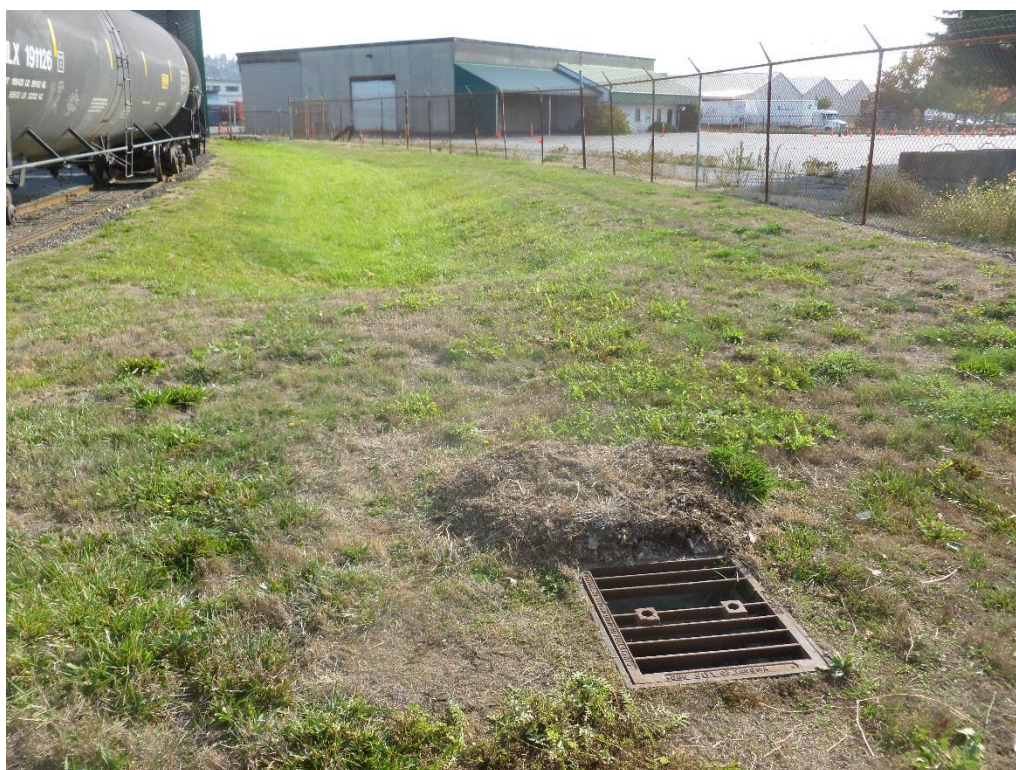
Mr. Garman explained that the catch basins are equipped with normally closed gate valves so that any spills can be isolated before routing stormwater from the catch basins to the detention vault. During rain events, he said that staff open and close the valves on an hourly basis. Flow from the detention vault is then pumped to a bioswale (**Photo 2**) prior to discharge. Mr. Garman said that the detention vault is cleaned on an annual basis.

Photo 2 / P1020787 – Easterly view of the catch basin that functions as the stormwater sampling point. The bioswale appears in the background

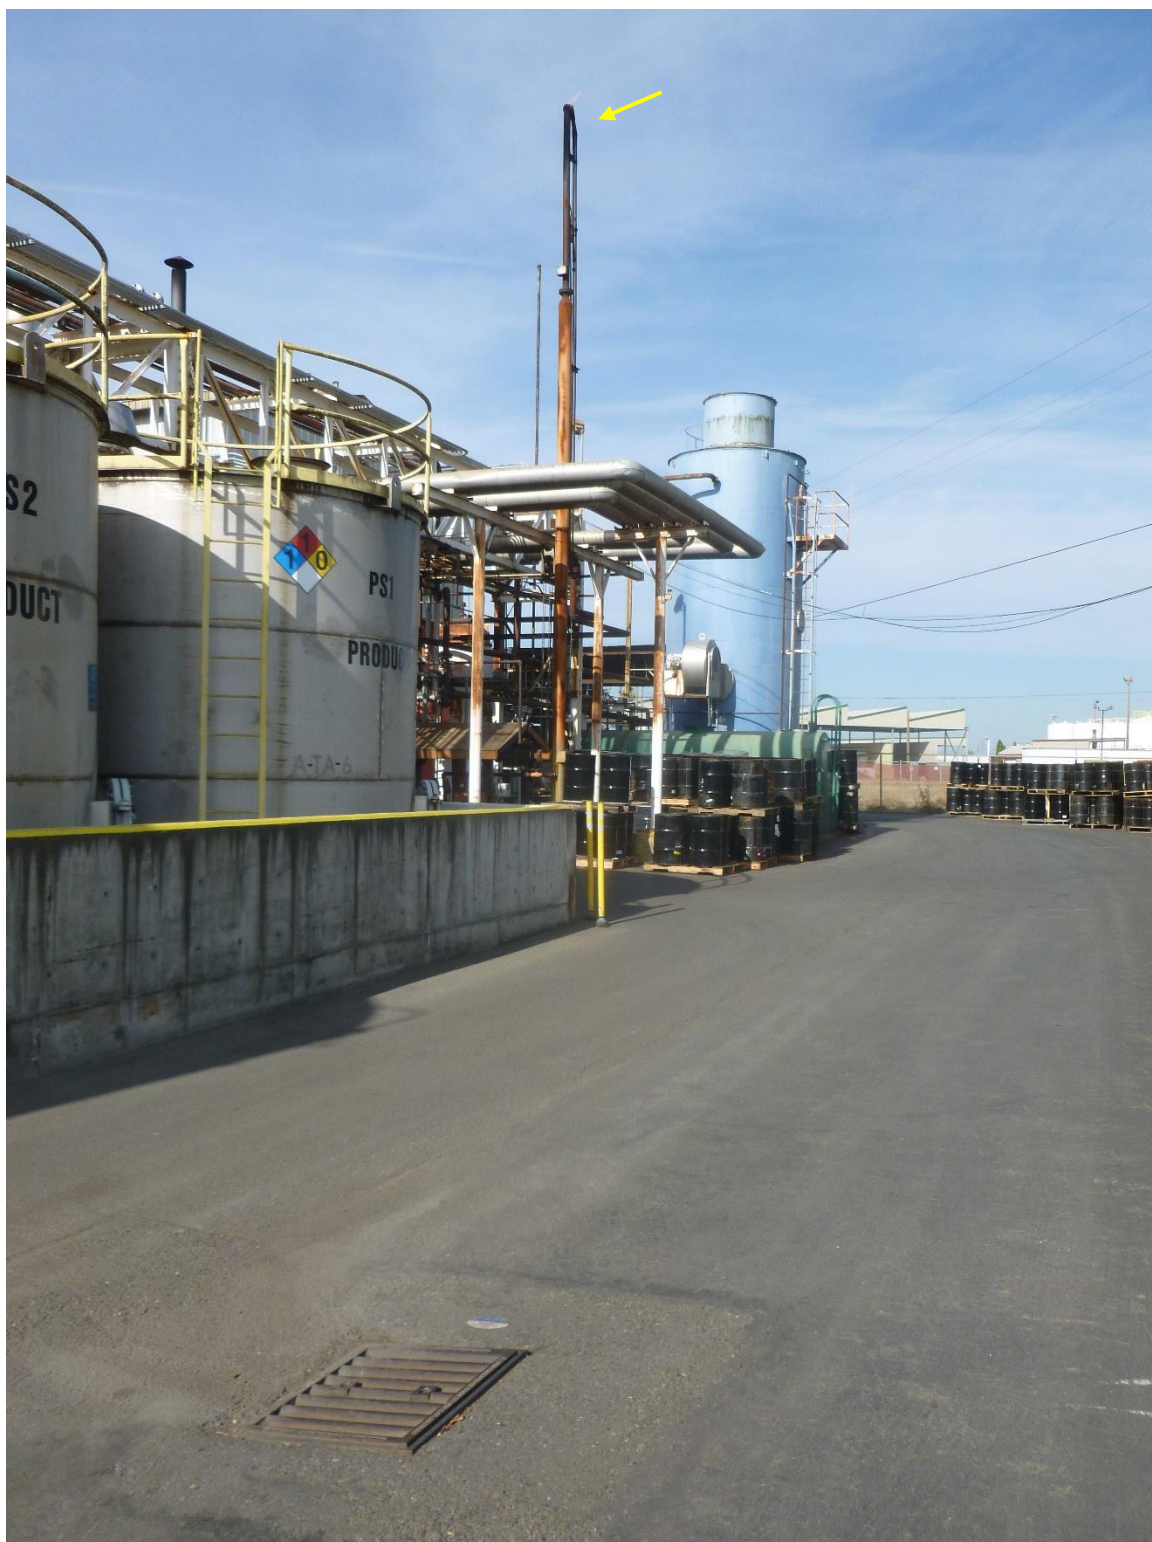
On the northeast side of the facility, I inspected the location of the last reported spill to a catch basin (**Photo 3**) in April 2015. Mr. Garman said that the spill resulted from an employee error that caused potable water to flood and overflow from a flare vent pipe. In this area, Mr. Garman also said that the facility periodically receives stormwater run-on from an unpaved Port of Tacoma property located northeast of the facility.

Photo 3 / P1020793 – Northwesterly view of a catch basin (foreground) on the northeast side of the facility. On April 24, 2015 the facility reported that the catch basin received flow resulting from an employee error that caused potable water to flood and overflow from a flare vent pipe. A yellow arrow indicates the location of this vent pipe.

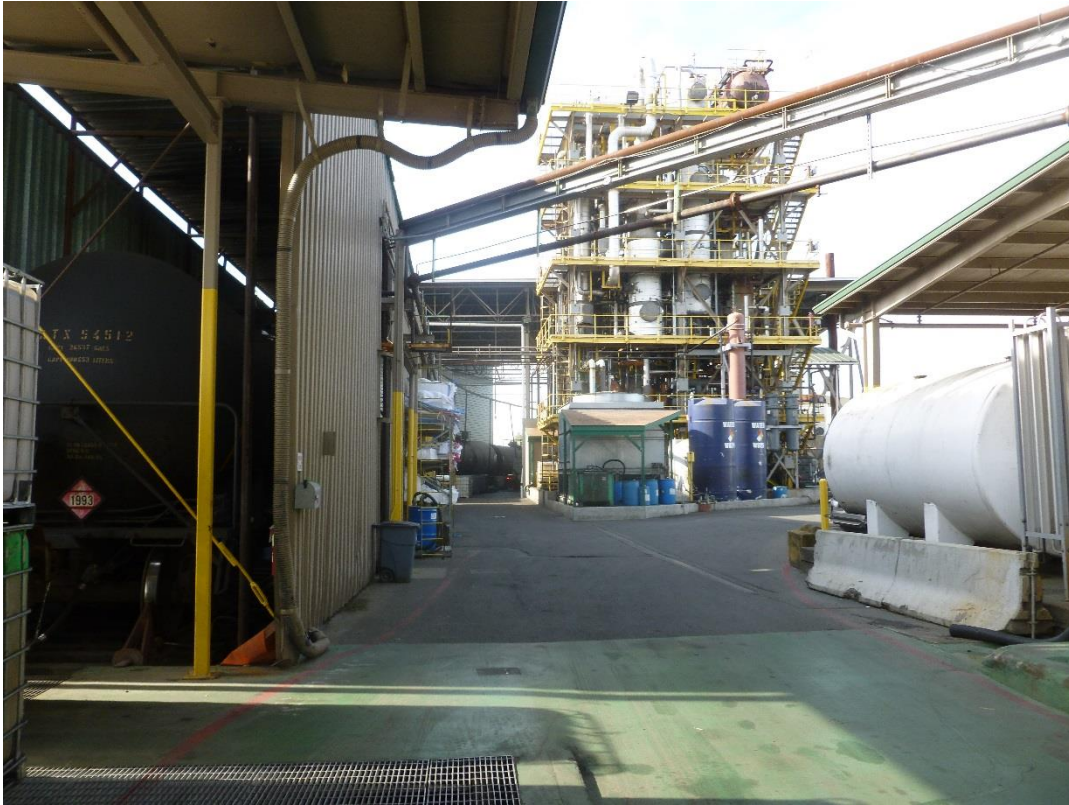
I also inspected the used oil re-refining facility (**Photo 4**) and rail car containment area, which are equipped with a separate containment vault. Stormwater from this area is hauled off-site for

Photo 4 / P1020791 – Southwesterly view of the used oil re-refining facility. The rail car containment area appears on the left.
